**Product:** Transpo's T-17 Rapid Patch  
**Project:** Airfield Pavement Rehab,  
CIP #4910-8107-3081, CIP ID# 6000-028  
**Location:** Bergstrom International Airport, Austin TX  
**Size:** 5-7,000 Square Feet, Min. 2.5" Deep  
**Engineers:** URS Corporation/CH2MHill, Austin TX  
**Contractor:** EAS Construction LP, El Paso TX  
**Project Manager:** Bobby McClelland

*November 18, 2008-New Rochelle, NY- Austin-  
Bergstrom International Airport (AUS) has been*

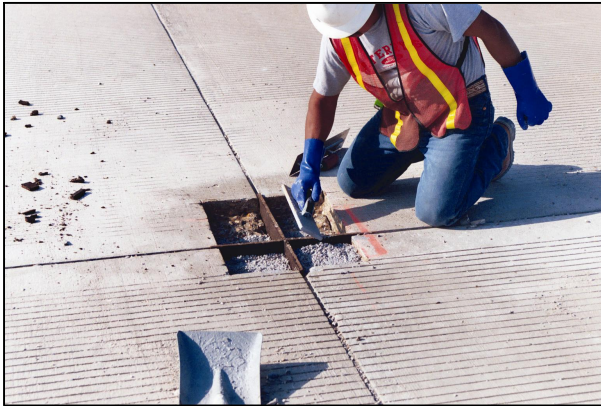
The airport's parallel runways were experiencing some spalling with the concrete at the construction joints. Because broken concrete pieces might be drawn into an aircraft engine, causing severe damage, airport engineers developed a rehabilitation project to repair all of the existing spalls.

Repair material had to have high-compressive bond strength and rapid cure time so the "down" time for runways could be kept to a minimum. Transpo's T-17 Methyl Methacrylate Polymer Concrete was selected to complete the repairs.

T-17 has a strong chemical bond (no cold joints), is waterproof and freeze-thaw resistant, as well as chemical and UV light resistant. With a large application temperature range (14-100° F) and rapid cure time (45 minutes at 70° F) a quick return to service is possible. T-17 is easy to handle in all working conditions and requires no special equipment. T-17 has been used at other airports for over 10 years and continues to be the material of choice for concrete runway and tarmac rehabilitation.
